Primary and secondary damage of limiter tiles in FTU induced by runaway electrons

M. De Angeli

WIP, Frascati 15/09/2025

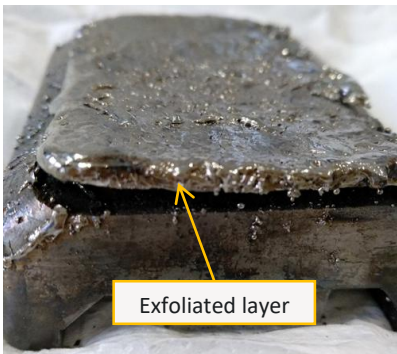
Poloidal tile, Feb-Dec 2019

- The **poloidal limiter** tiles at the mid-plane were the **preferred termination location of REs** due to the outward shift of the RE orbit, *typically during start-up and ramp-up phases*;
- Such tiles were the **primary localized PFCs damaged by REs**;
- Observed damages: (i) *surface or deep melting*; (ii) *surface layer exfoliation*; (iii) *cracks*.

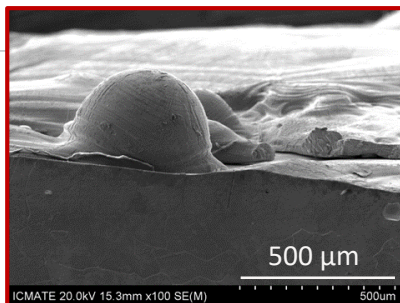
Top surface view:
molten layers

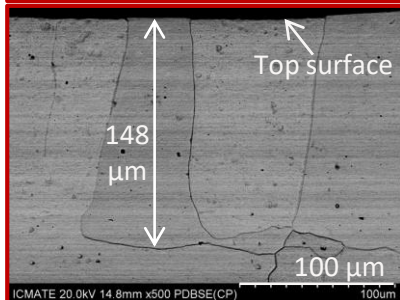
Cross-section view just below the top surface:
vertically columnar grains
→
experienced melting and temperature gradient.

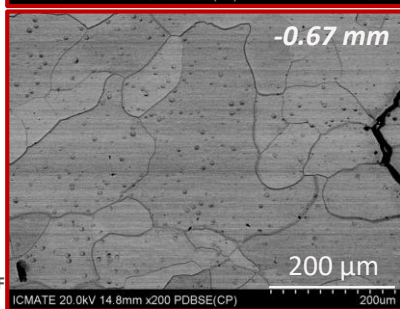
Cross-section view
0.67mm below the top surface:
equiaxial grains
→ likely underwent recrystallization.

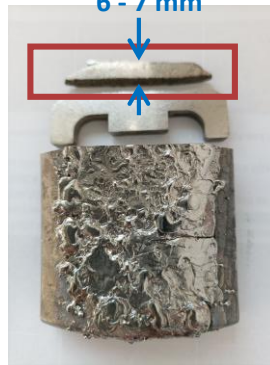
Poloidal tile, Apr 2017-Feb 2019

Upper piece
Thickness:
6 - 7 mm

Apparent total
damaged depth
from grains size
analysis: ~1200 μm.

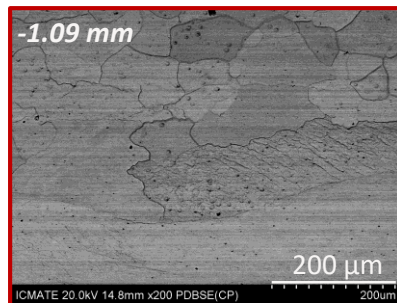
Cross-section view
1.09mm below the top
surface:
*horizontally elongated
grains* → likely result
of the manufacturing
route.

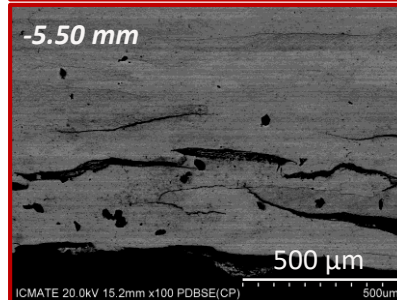
Cross-section view,
bottom surface:
*horizontally elongated
grains and cracks* → no
recrystallization but
thermal fatigue.

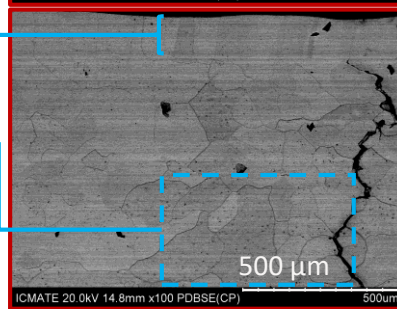
Cross-section view just
below the top surface:
*Example of inter-
granular crack in bulk.*

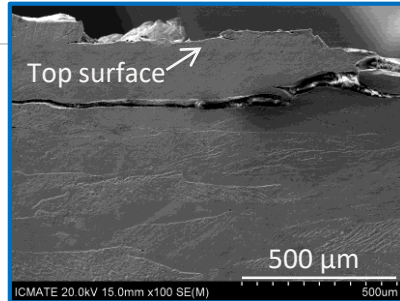
Cross-section view (-2.98 mm):
horizontally elongated grains
→ *manufacturing route*.

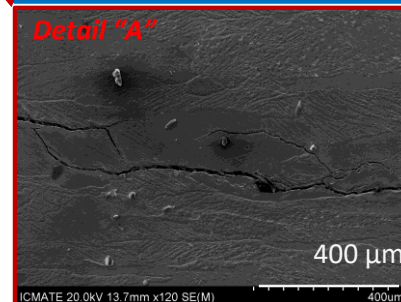
Detail "A": few mm long inter-granular crack
→ *thermal cycles stress*.

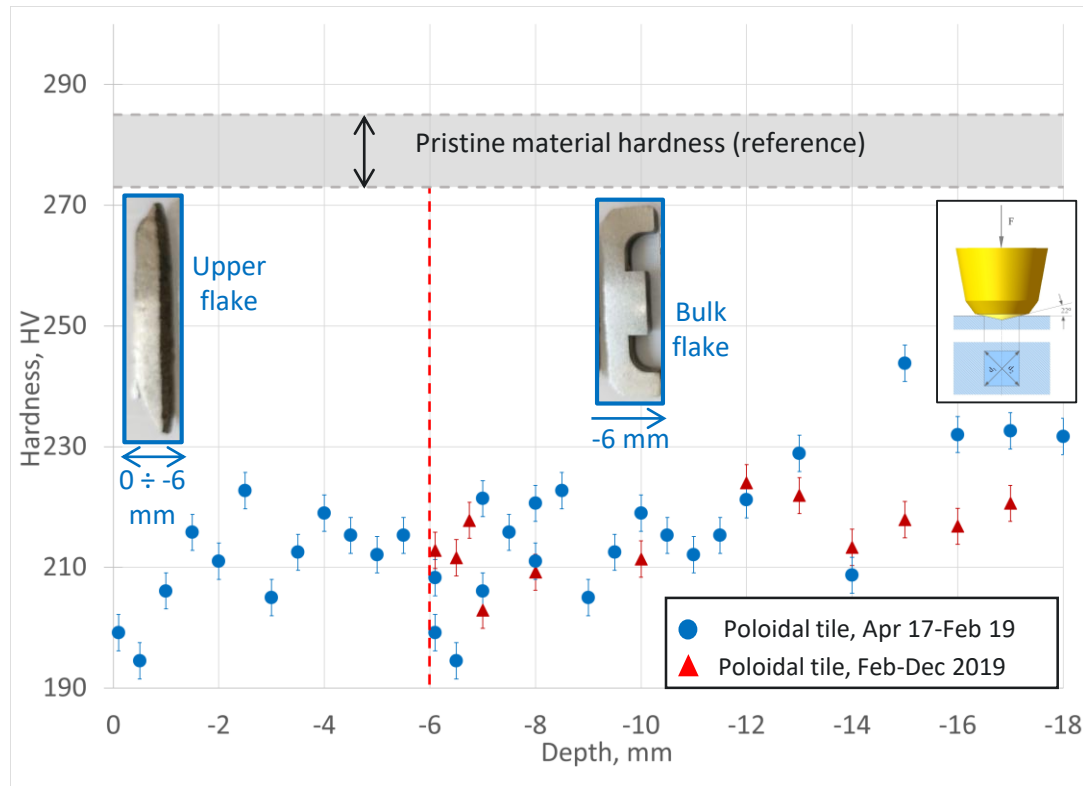
- Carried out **microhardness tests** in **Hardness Vickers scale** ($HV_{0,2}=200$, accuracy: ± 3) along cross-section profiles of poloidal tiles.
- No appreciable differences** along the cross-section between upper and lower pieces.
- Degradation of ~ 65 HV compared to a pristine material** (279 ± 6 HV, i.e. never exposed to plasma/REs).

Graphic of cross-section hardness in Vickers scale for two different poloidal tiles.

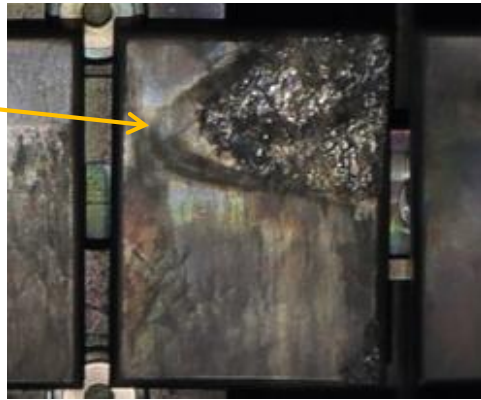
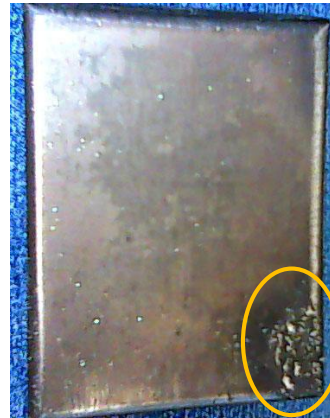
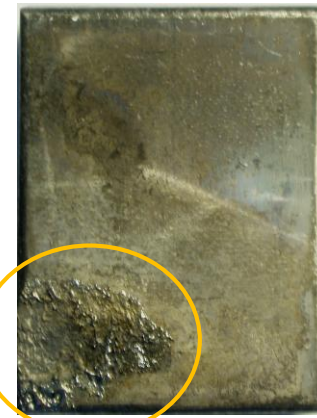
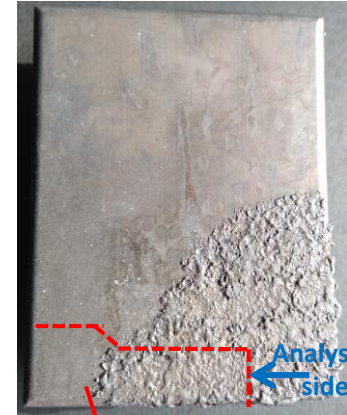
- The **toroidal limiter** was hit by RE beams randomly along the toroidal direction, do not having any preferred termination point, by inward RE beams following some plasma disruptions [1];
- Observed damages: (i) *surface or deep melting*; (ii) *cracks*; (iii) *structural degradation of a few mm in depth*.

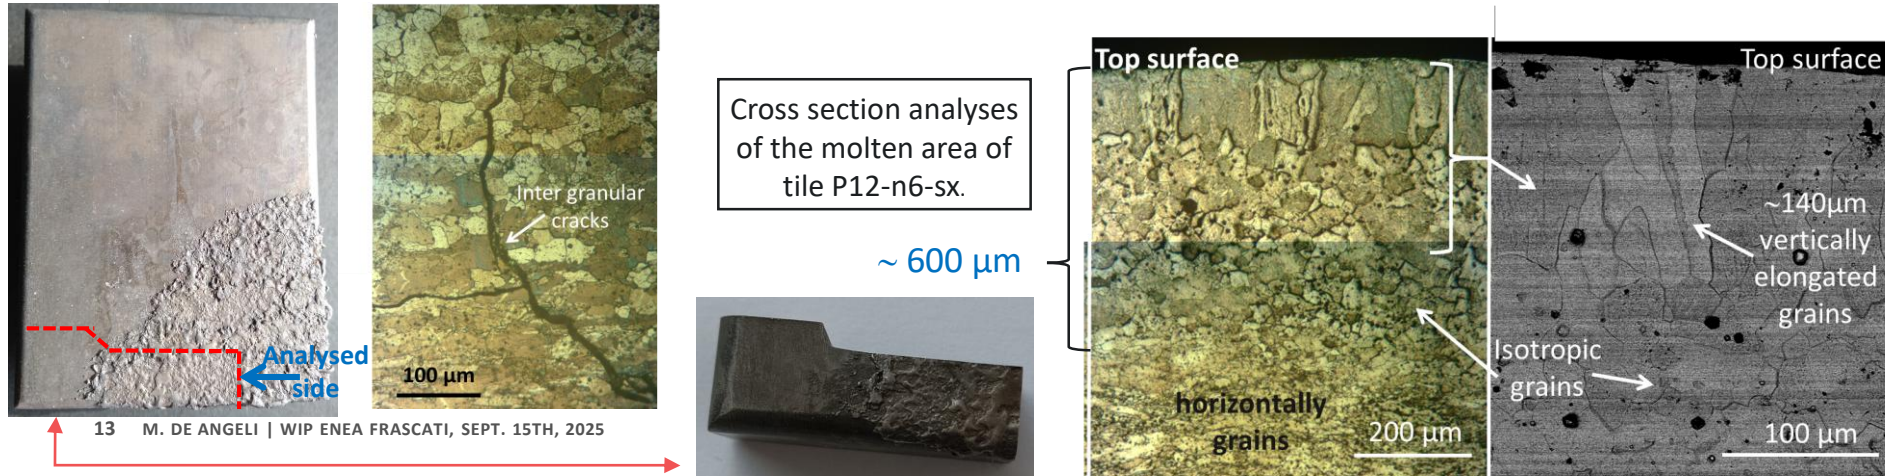
- A toroidal limiter, hit by RE beam, was cut in the molten area surface and the resulting cross-section was analysed by mean of Electron and optical microscope, and hardness test device;
- Found less pronounced structures than for poloidal tiles (i.e. vertically elongated, equiaxial, and horizontally elongated grains);
- Millimeter long intergranular cracks.

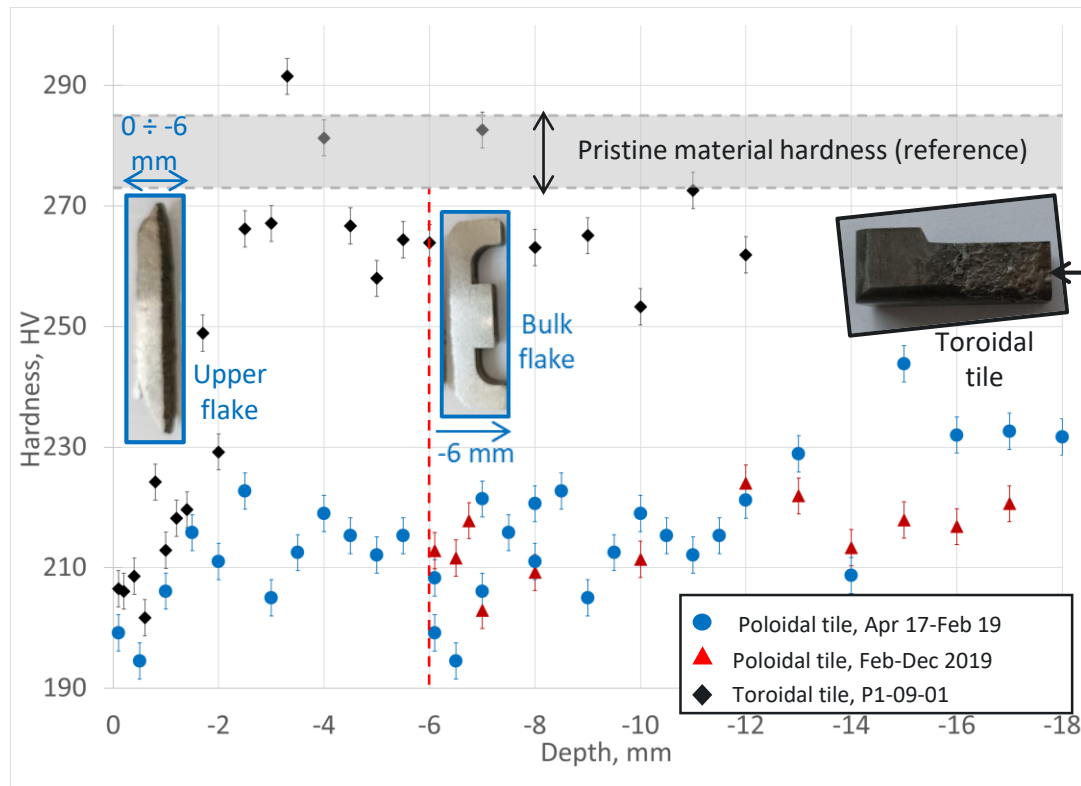
- Carried out microhardness tests in Hardness Vickers scale ($HV_{0,2}=200$, accuracy: ± 3) along cross-section profiles of poloidal and toroidal tiles.
- On the contrary of the poloidal tiles, a hardness degradation of ~ 65 HV was observed only in the first ~ 2 mm below the upper surface of the toroidal tile (maybe also due to the shallow RE beam incident angle).

Graphic of cross-section hardness, in Vickers scale, for two poloidal and one toroidal tiles.

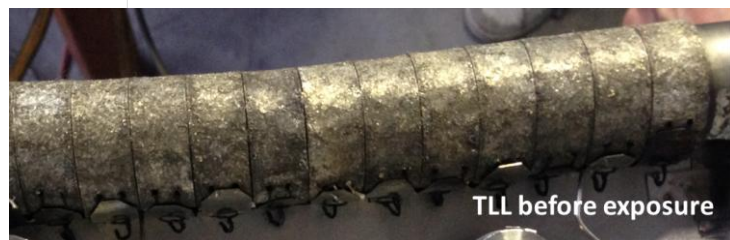
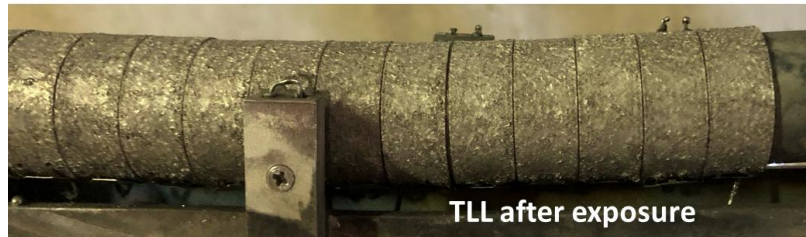
- The **tin liquid limiter** (TLL) where exposed in FTU Port 1 (bottom) from Sept 2016 to Dic 2019;
 - in some cases of VDE followed by disruptions, during elongated plasma configurations, **RE beams hit the TLL**;
 - the TLL was consisting of a capillary, actively cooled, porous system (CPS): a W wire network, diameter $\sim 50\mu\text{m}$, pores $\sim 30\mu\text{m}$ **filled with a 10-100 μm layer of liquid tin** [1];
- ⇒ Visual inspection led to the conclusion that the W TLL mesh **was not macroscopically damaged** after exposure to plasma and RE.

TLL image before (left) and after (right) exposure in FTU experimental campaigns.

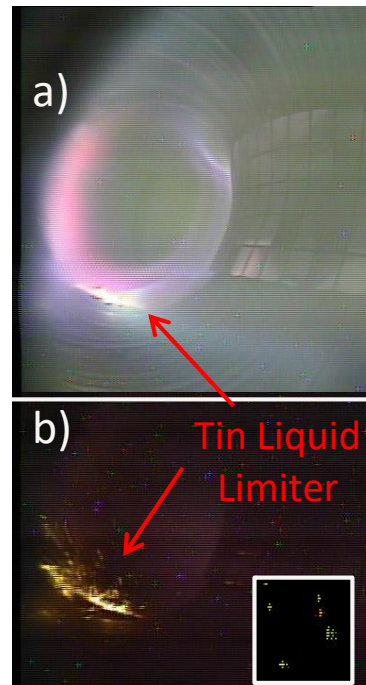
Vis camera of shot #42706 (disruption). Frame just before (a) and after (b) explosion like-event due to RE beam striking on TLL. Note the insert in fig. (b) showing camera pixels saturation by γ or hard X-rays bursts.

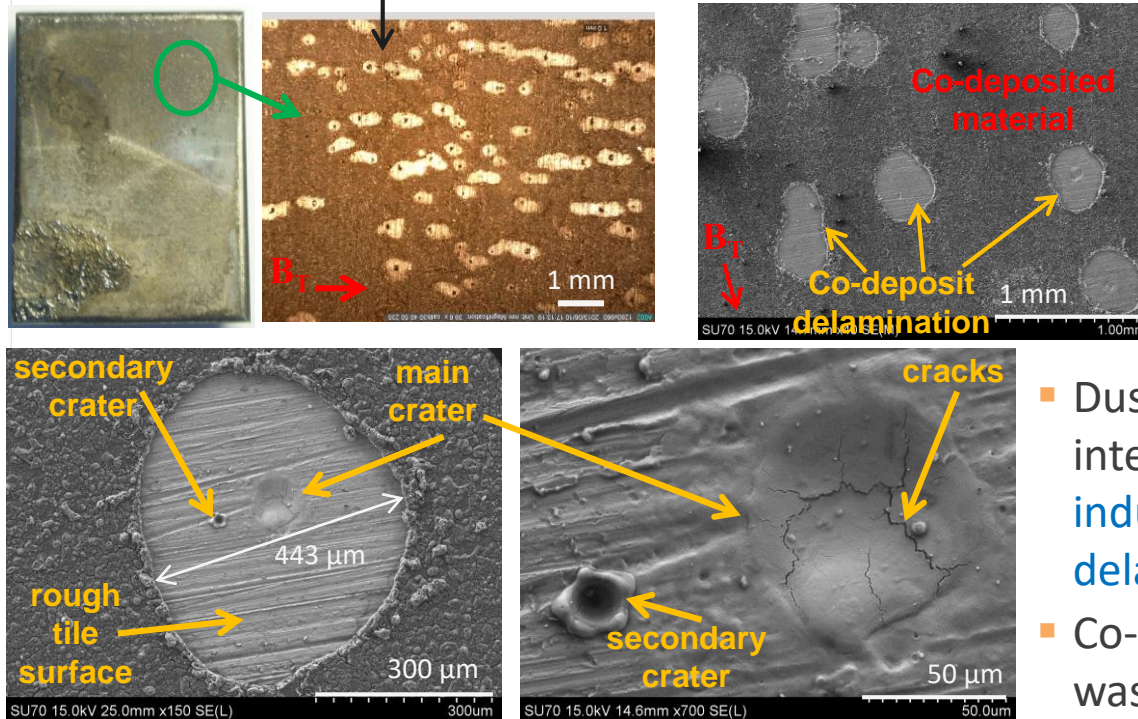
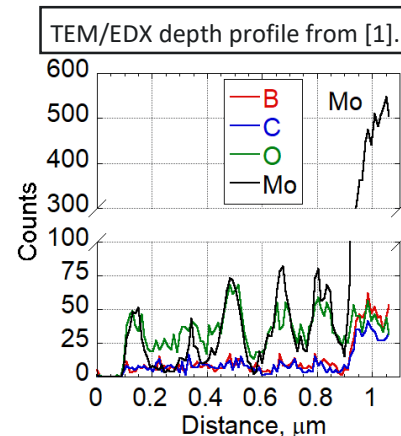
Toroidal limiter tile P12-n6-sx along with optical & electron microscope images of craters at different magnification.

- Dust ejected, upon RE beam interaction with the poloidal tiles, induces craters & co-deposit delamination on nearby PFCs [1].
- Co-deposit on toroidal tiles in FTU was, mainly composed by Mo oxide.

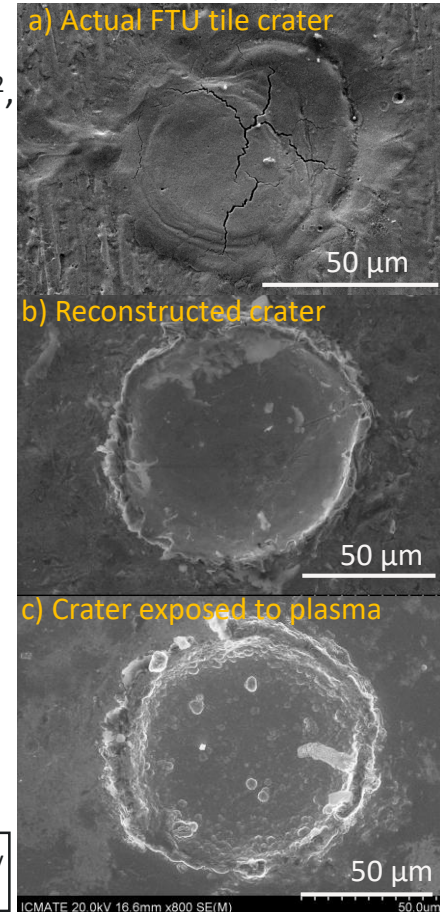
→ **Morphology well reconstructed;**

✗ **Cracks not reproduced:** thermal stress, or increase of ductile-brittle transition temperature due to irradiation.

SEM images of a) actual FTU crater, b) crater by gun system, c) crater after plasma exposure.

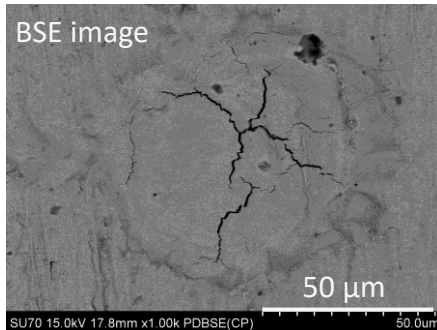
- Cracks are found inside several craters.
- Cracks width: 50nm - 1.3 μ m.
- Cracks depth: ? difficult to carry out FIB cross-section inside deep craters!

SEM image of a crater with crack network.

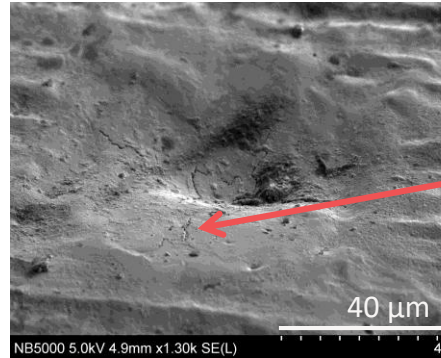
SEM images of the crack cross-section. Crack total depth: 9.3 μ m.

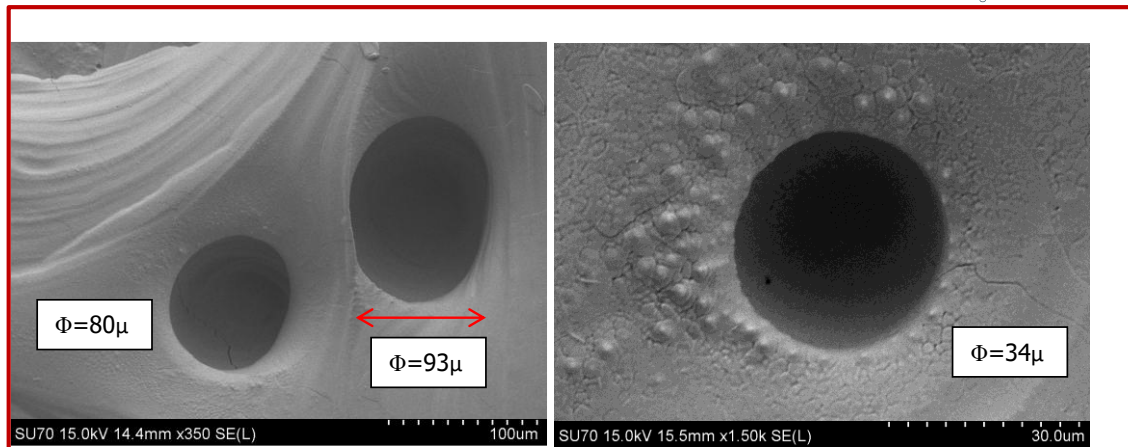
Holes found on the molten area
on a TZM toroidal limiter tile

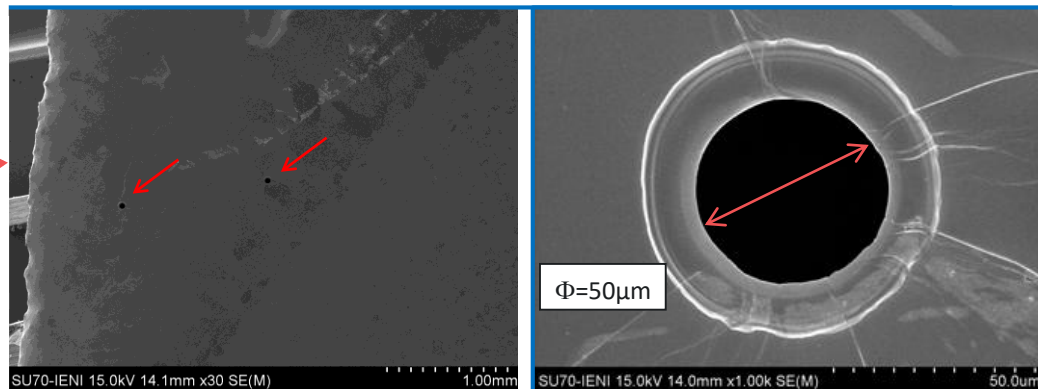
Holes found on a Mo tip
exposed in SOL area of FTU
during few discharges with REs
