Primary and secondary damage of limiter tiles in FTU induced by runaway electrons

M. De Angeli

WIP, Frascati 15/09/2025

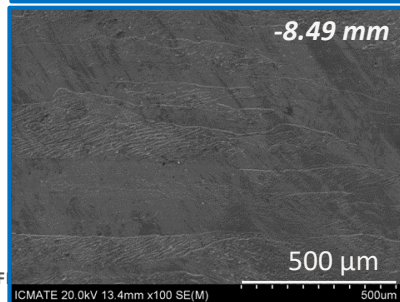
Cross-section view (-8.49 mm):
horizontally elongated grains
→ *manufacturing route*.

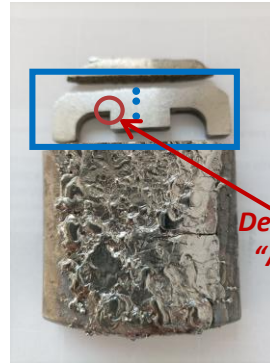
Poloidal tile, Apr 2017-Feb 2019

The grains structure, along the whole cross section, is almost constant → *manufacturing route*.

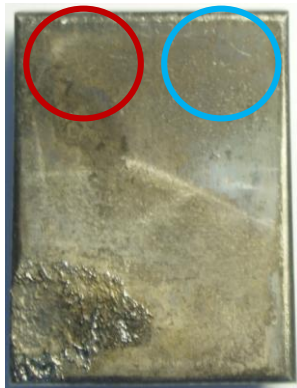
Toroidal tile T2 P12-n6-sx

- **Circular and elongated** co-deposit delamination shape were found.
- Different average delaminated areas in different limiter tile locations.
- Craters average density: $\sim 71 \text{ crat./cm}^2 \rightarrow$ **delaminate surface that could be removed: $\sim 0.6\% \div 9\%$** (all circular to all elongated delamination).
- Co-deposit thickness on T2: $\sim 8\mu\text{m}$.

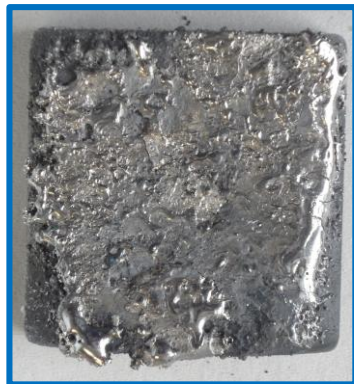
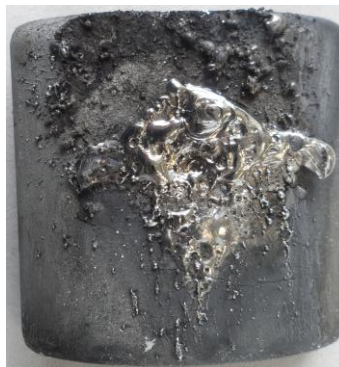
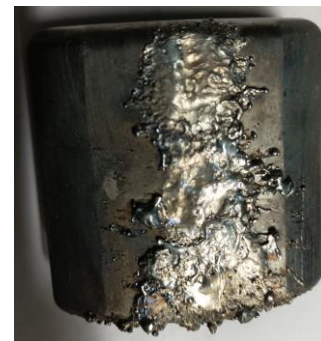
Additional examples of damaged poloidal limiter tiles
